Vetiver Grass System for Erosion Control on Severe Acid Sulfate Soil in Southern Vietnam

Le van Du¹ and Paul Truong²

Abstract: The banks of drainage and irrigation channels in the acid sulfate soil (ASS) region of southern Vietnam are highly erodible due to weak or no physical structure and the extremely acidic chemical conditions. With these soil properties, most plants cannot survive; especially during dry season hence erosion is severe and results in costly repairs.

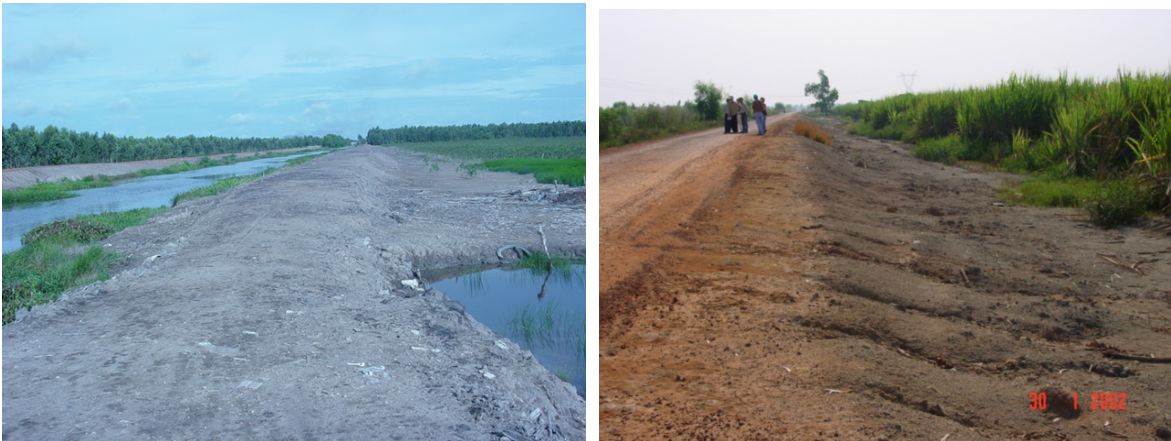
Photo 1: Severe erosion on canal and rural road on Acid Sulfate soil

Agricultural lands in southern Vietnam have been substantially expanded in the last two decades to increase food production, especially on marginal lands with the adverse soil conditions, including saline and acid sulfate soils. On these soils, the establishment of drainage and irrigation channels is the most important technique for improving agricultural and fishery production. However the embankments of these systems are highly erodible due to weak physical structure and extremely acidic in chemical properties. With these soil properties, few plants can survive; especially during dry season hence erosion is a severe and costly problem (Photo 1)

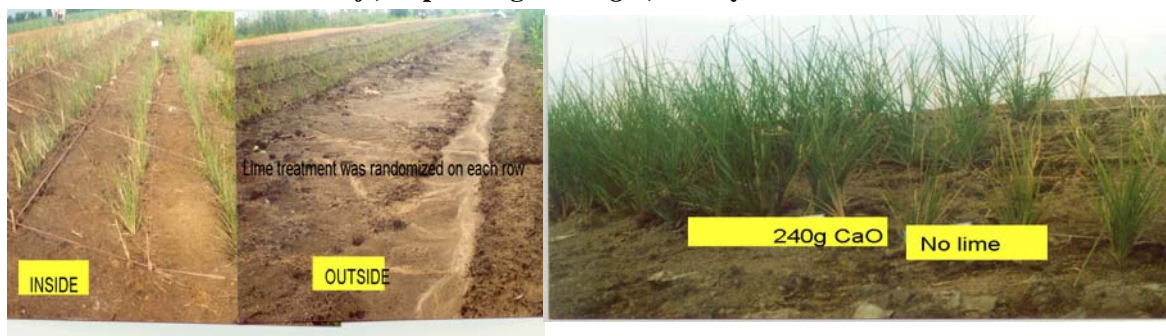
Photo 2: The effect of liming on growth and establishment of vetiver.
Left, at planting and Right, 45 days later

The objective was to determine the effect of liming on the establishment and growth of vetiver grass. Three liming rates: 0, 120 and 240g (as CaO) per linear metre row were used. After three months, plant height, tillers and shoot growth of the 240g treatments increased more than 3 times than that of the control (Photos 2 and 3).

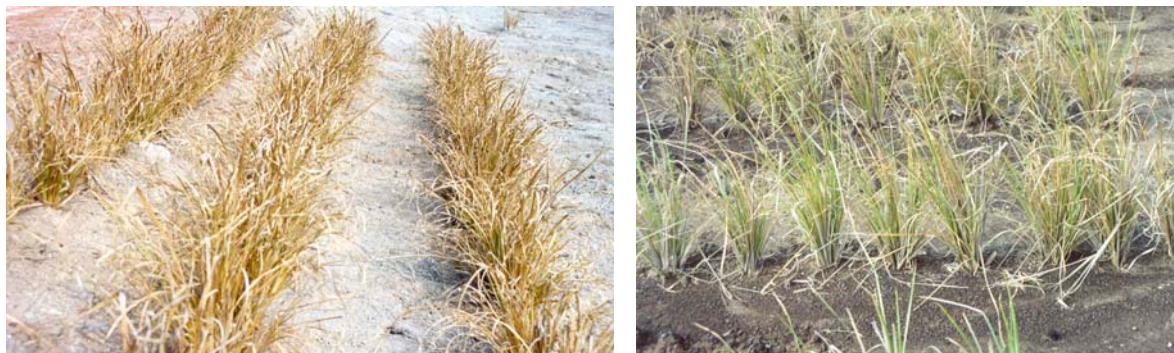
Photo 7: The effect of lime, N and P on vetiver growth.
Left, six months without rain Right, after 20mm of rain

With adequate liming all plants grew vigorously nine months after planting. During the six-month long dry season, all plants seem to be dormant, most leaves were scorched, but they all survived and resumed vigorous growth just after 20mm of rain (Photos 6, 7 and 8)

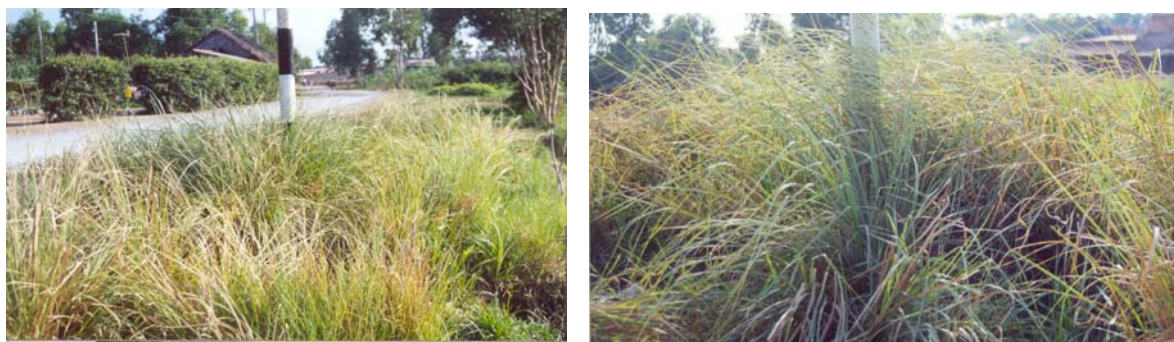
Photo 8: The effect of flooding on vetiver grass growth.
Left, six months without rain Right, after 20mm of rain

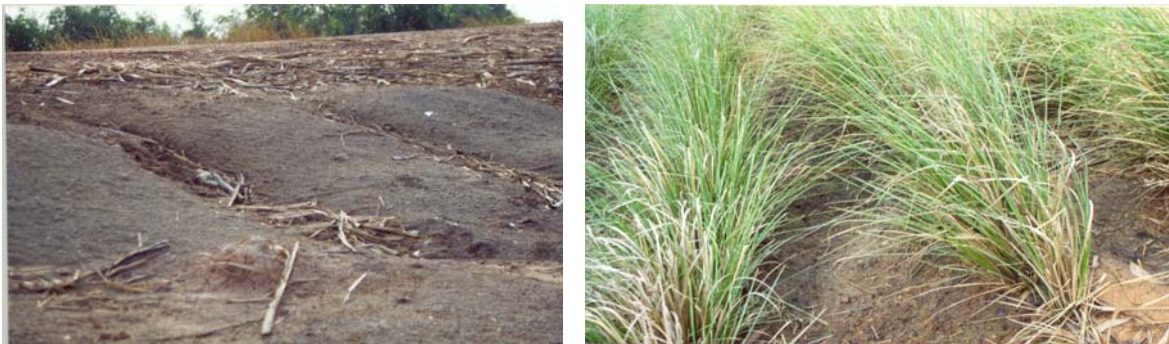
Photo 9: Soil loss was reduced from 400-750tons/ha to only 50-100tons/ha on the channel embankment

The erosion was markedly reduced on both sides of the embankment with vetiver grass treatment. Soil loss was reduced from between 400 and 750 tons/ha/4months to only 50 to 100 tons/ha with vetiver grass hedges (Table 7).

Stability of channel banks was greatly improved with vetiver grass planting. Over the period of four months, soil loss by erosion was markedly reduced, from 400-750 tons/ha to only 50-100, on both sides of the embankment (Photo 9).
